## Strait of Istanbul, major accidents and abolishment of left-hand side navigation

Cahit İstikbal

İstikbal, C. (2020). Strait of Istanbul, major accidents and abolishment of left-hand side navigation. *Aquatic Research*, 3(1), 40-65.

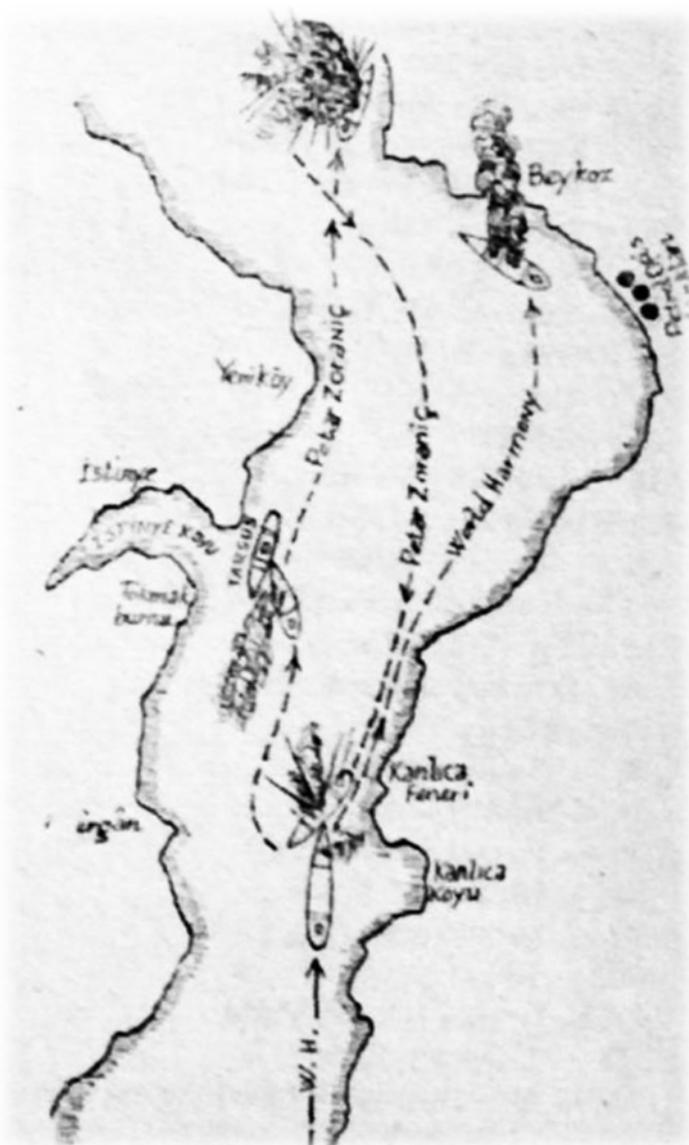
**Figure 2.** Petar Zoranic- World Harmony accident on an estimated simulative diagram (Koçu,1963)

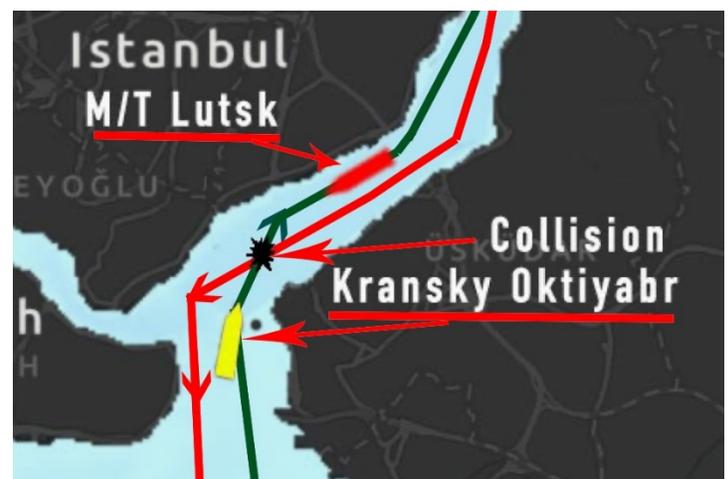
**Figure 6.** Positions 4 minutes before and place of collision of Lutsk and Kransky Otkiyabr

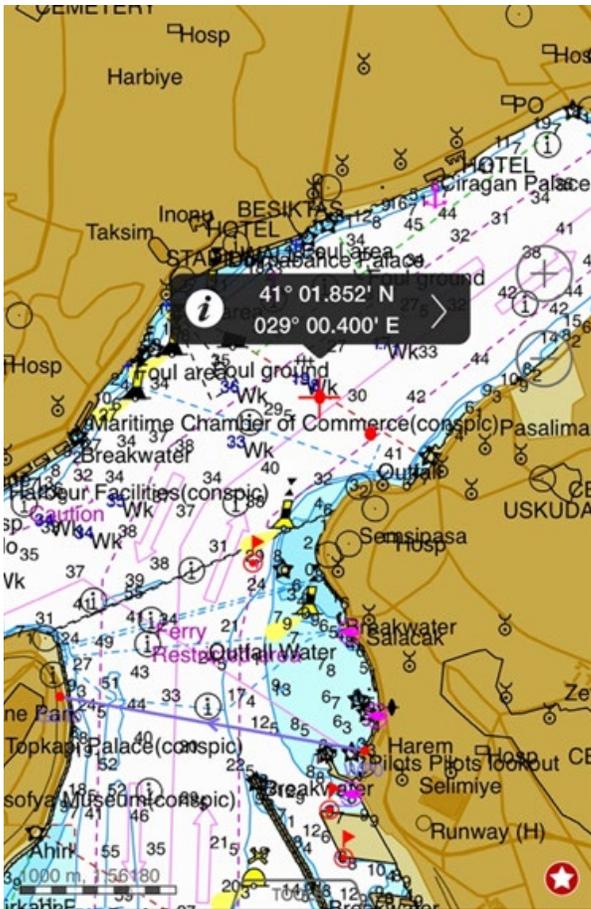
**Figure 7.** Exact position of the Lutsk-Kranskiy Otkiyabr accident. Position fixed by the officers on the bridge of Kranskiy Otkiyabr: 41 01.85 N and 029 00.40 E

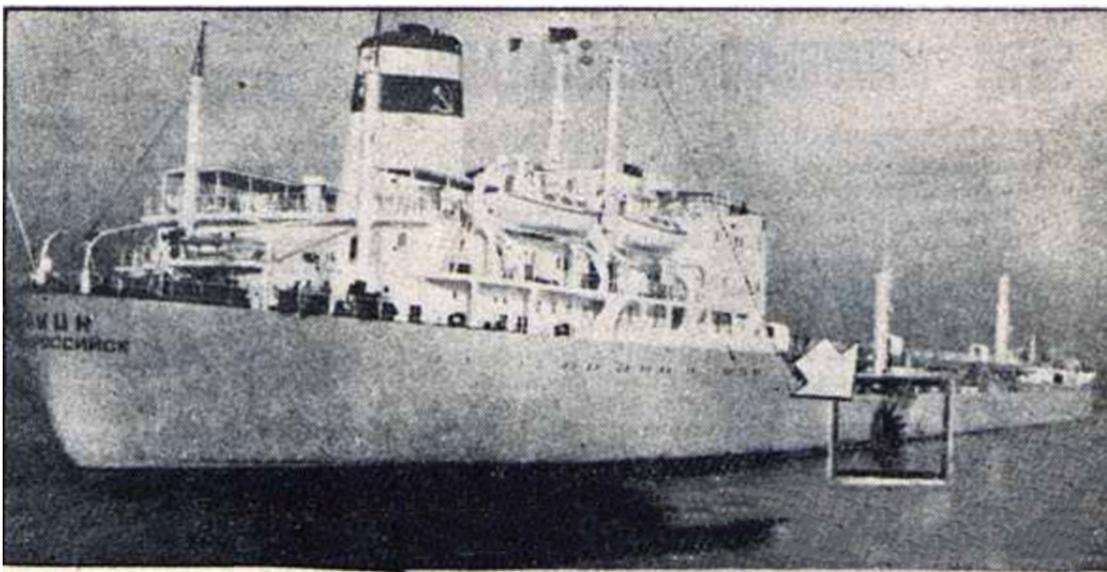
**Figure 8.** This photo, Property of Özdemir Gürsoy and published on Daily Milliyet Newspaper on 03.03.1966, shows the damage on the starboard side of tanker Lutsk.

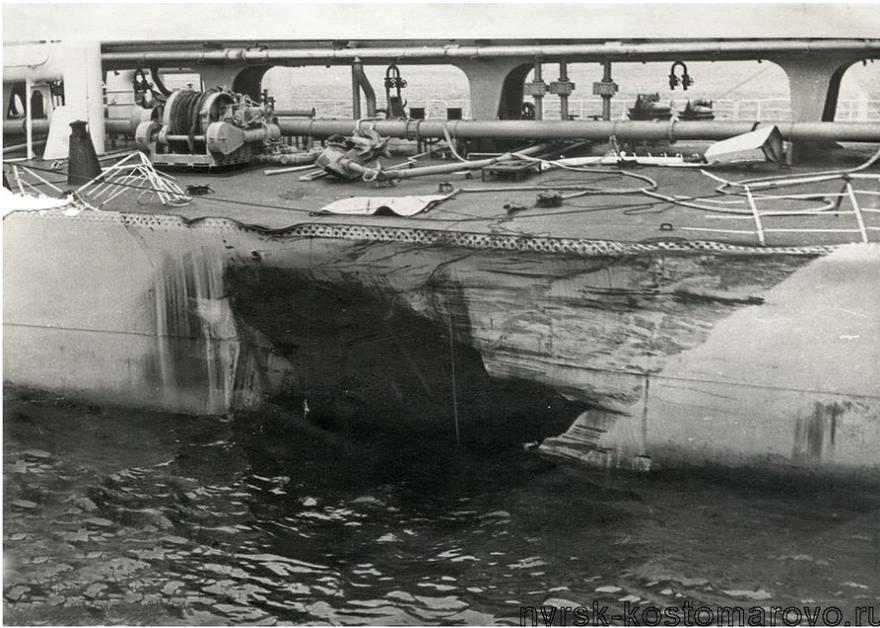
**Figure 9.** The damage on the single-hull Lutsk shows the gravity of possible disaster which was very near to happen.

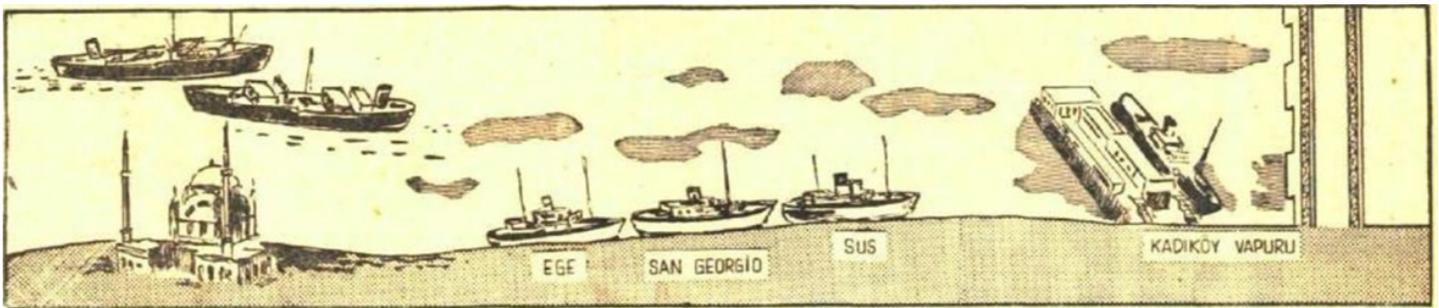
**Figure 10.** The illustration of the Lutsk-Kransky Otkiyabr accident published on daily newspaper Cumhuriyet on 03/03/2019

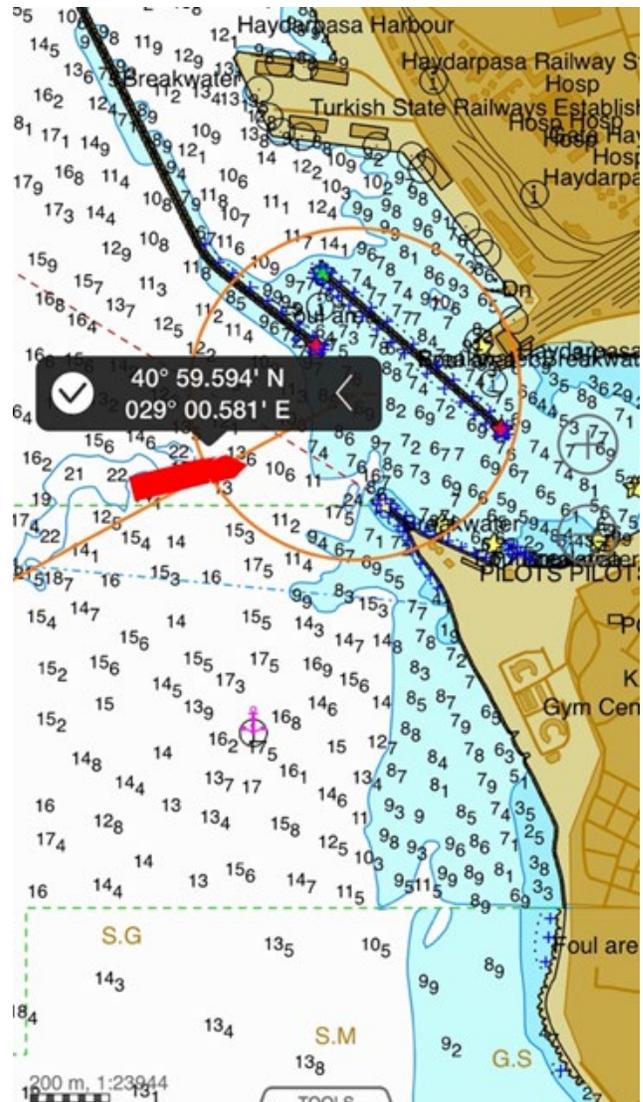
**Figure 15.** The location where Independenta went aground

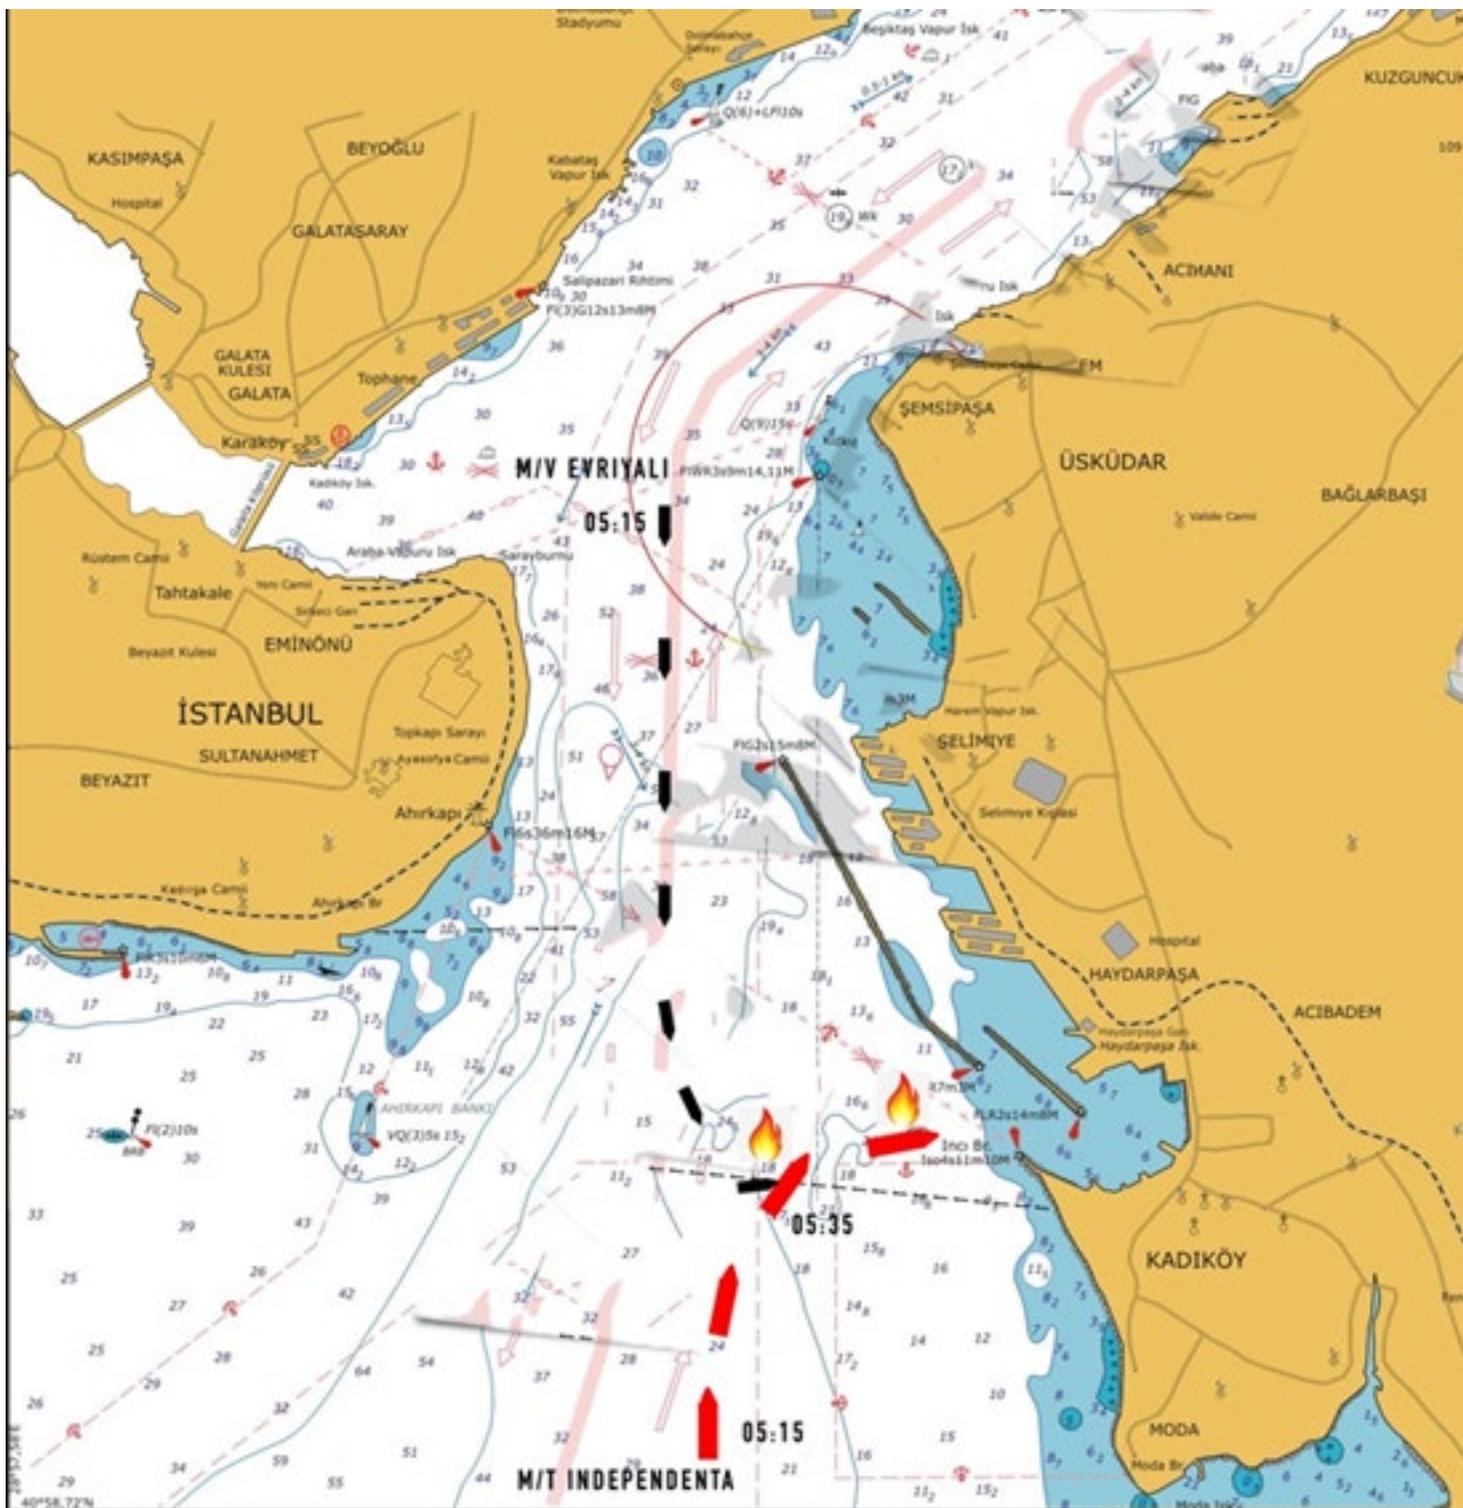
Evriyalı's stem, close to the starboard bow, crashed into Independenta on the port side, on No. 3- No. 4 tanks area, just in front of the accommodation. Especially No.4 tanks were critical area because these tanks did not contain crude oil, but gasoline. Soon after the crash, crude oil started to pour out from the tanks and sparks due to metal-to-metal friction, pouring crude oil-or gas- caught fire, and afterwards, there was a huge explosion, due to which, all the windows glasses in a 6 km diameter in Istanbul city were broken. Abandon ship bells rang on board Independenta. Chief Engineer of M/T Independenta, Sorin Mihăilescu, described the tragic moments as follows (Cumpana, 2006): "I went on the bridge. The first who saw the Evriyalı ship was Commander Mihai Dorinel. He was focused and seemed a little anxious. I also saw the ship heading in the opposite direction towards us. At one point, the commander noticed the wrong direction. The foreign ship did not sail "on the starboard side" to show us her port side, as was the rule. We all thought he was a little off the road and that he would soon correct his course. Our commander put his handset on the radio and sent them to come «port to port», that is to pass parallel with us and to see the red light from his port side, as he saw the one from our port. It is an elementary rule of sea navigation at night. No one answered. Later, I learned that the ship, though passing through the Strait, had no pilot on board, the commander was not in command, and permanence was ensured only by the ordinary crew, an officer, a helmsman and a sailor. I never understood what was their intention. Maybe they bet on the routine, maybe they didn't even see us, maybe they were disconnected because they were just getting out of trouble, maybe they were worried about something else. There were some rumors that they had women on board or that they were doing "business" with the locals who were fishing in the area. Mihai Dorinel kept calling him over the radio. The other ship was silent. It was now 5.20. The foreign vessel continued to proceed towards us. We were beginning to distinguish their profile and dimensions. It was a cargo of about 5,000 DWT. Later I found out that it was called "Evriyalı", it was private property, under the Greek flag and carrying steel product. Within minutes, our commander's calls began to become more and more agitated. I was worried about his voice. At that moment, the whistle of our ship came into operation; their thick and frightening scream was a desperate attempt to warn the stranger of our presence and imminent danger. But the ship in front of us gave no sign, instead, it changed course and turned perpendicular to ours. Due to the size and weight of the "Independence" tanker, any avoidance manoeuvres were impossible. The "Evriyalı" had come close enough to see its light from the starboard, and not from the port as normal. There was nothing left to

Figure 16. Estimated collision tracks and site of collision of M/V Evriyalı and M/T Independenta

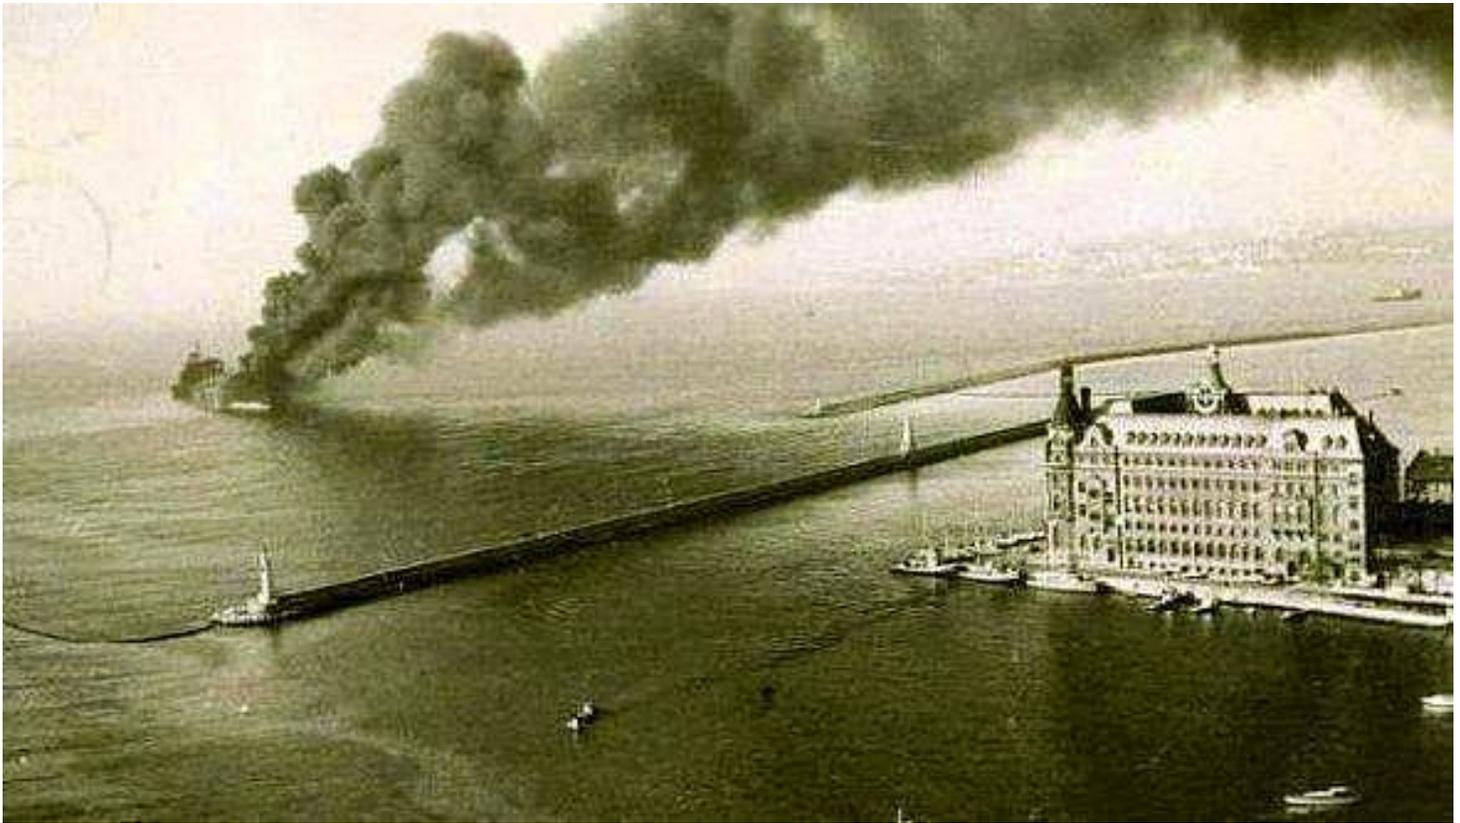
**Figure 17.** Independenta aground and on fire right before the Haydarpaşa breakwater. Source: <https://onedio.com/haber/11-maddede-bogaz-daki-en-buyuk-tanker-faciasi-independenta-515265>
