Determination of Wear That Can Be Formed at the Cast Iron Wheels of the Centrifuge Pumps Used at Agricultural Irrigation*

Abstract: The extent of this work is operating characteristics of a horizontal shafted centrifugal pump (which has cast iron with lameller graphite wheel) which has been operated for 7 hours on the average. A closed circuit pump system (circulating within itself) which was formed by attaching a horizontal shafted centrifugal pump which can be used in irrigation applications with a drum has been operated for 150 hours at laboratory conditions. To define the operating properties of the pump, its operating characteristics were measured in respect to TS EN ISO 9906/AC. Furthermore, observations have been done to determine whether there is a connection between operating characteristics of the pump and the wear and corrosion occurred on the wheel or not. When spectral analysis, micro-structure and hardness measurements of the wheel materials on which first and second experiments were conducted and unused wrought iron wheel materials were analysed, it has been observed that the wheel materials used in the experiments do not bear the properties required by wrought iron

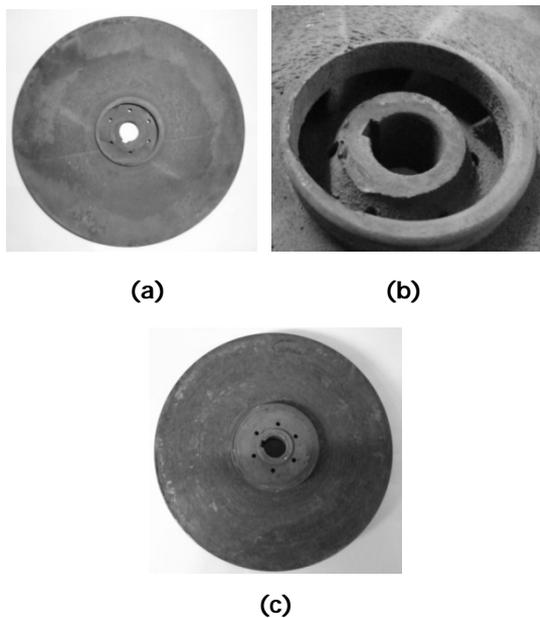
Figure 10. Macro structure images of pump wheel whose trial was done in the second 150 hours.

As the case in the wheel image of first 150 hours, traces of tarnish and corrosion are observed prominently on both sides of the wheel (Figure 10). Especially at the outer part of the hub traces of tarnish and corrosion are observed prominently. On the other side of the wheel corrosion has started but has not covered the entire surface yet.

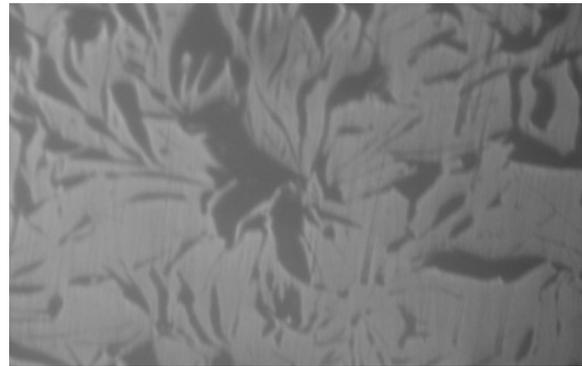
Figure 11. Micro structure images of pump wheel whose trial was done in the first 150 hours.

Graphite type of materials whose micro structure images were given is A+C, perlite rate is 85-90 % and graphite size is 3-5.

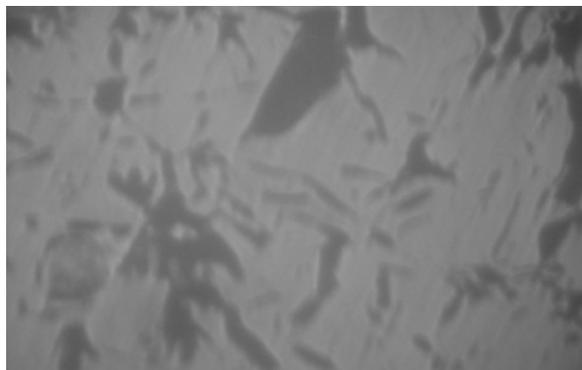
Figure 12. Micro structure images of pump wheel whose trial was done in the second 150 hours.

Graphite type of materials whose microstructure images were given is A+C, perlite rate is 70-75 % and graphite size is 2-4.

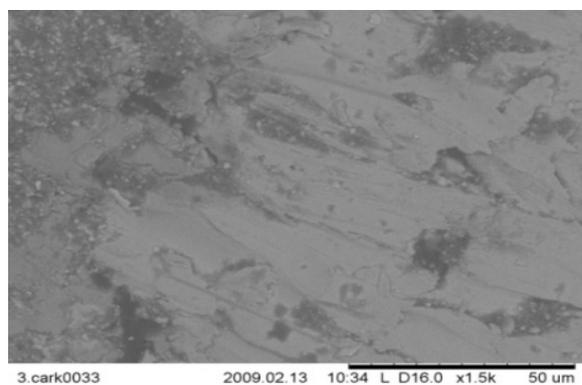
Figure 13. SEM image from the corroded surface of pump wheel

Traces of corrosion are observed prominently in the image obtained from the outer surface of pump wheel (Figure 13).

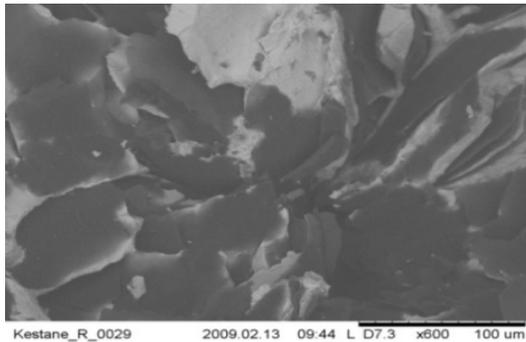
Figure 14. SEM image taken from diffraction section of corroded pump wheel material.

In the image obtained from the inner surface of the pump wheel, it is seen that the inner structure of the cast-iron material has a flower-like image. When the image is observed, it is seen that there is no deformation and corrosion has not advanced up to here and it has no difference with the inner surface of the wheel material whose trial has not been carried out yet (Figure 14).

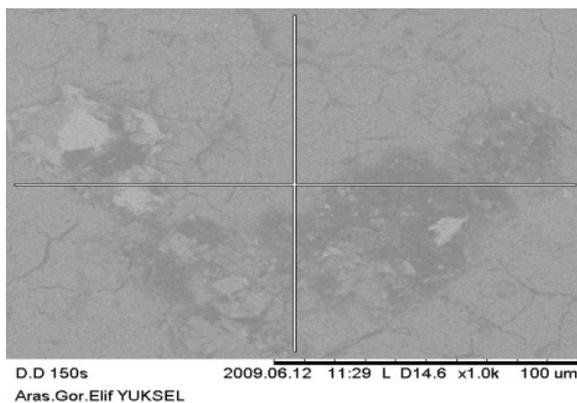
Figure 15. SEM image taken from corroded surface of the pump wheel material.

When the outer structure of the pump wheel is observed, although there is no prominent change in the material tissue of the cast-iron material, it is seen that there are little gaps in the very middle and there are fine small cracks spread all over the surface (Figure 15).

When the scanning electron microscope (SEM) of cast-iron pump wheel materials whose trial was done was observed, it was detected that there are thin hair cracks spread all through the surface, metal surface is in partial contact, traces of erosion which is an abrasion type that occurs with the effect of corrosive fluid that moves relatively were detected. When the images taken from the cracked inner surface of the material are observed, it was detected that there is no difference between the inner surface of the material and pump wheel itself so deformation has not reached here yet. In the micro structure observations of pump wheels done with SEM, it was detected that corrosion has occurred on the outer surface of pump wheel due to abrasion. Both effects may cause pump wheel not to work properly by influencing first outer later on inner part of the pump wheel. That the abrasion of cast-iron material structure is observed more on the outer surface and therefore craters that occur due to fractures on the structures would cause cracks in the further periods. In order to take structural precautions that would prevent both abrasion and corrosion on both inner and outer surface of the pump wheels, correct production methods must be used. For this reason, surface hardening methods are suggested. Developing surface

quality due to hardness would also enable water flow and friction between water and pump wheel would be minimized. At this stage of pump wheel production, good results can be attained in the sense of efficiency in construction, abrasion problem and minimizing corrosion by using functional graded material.

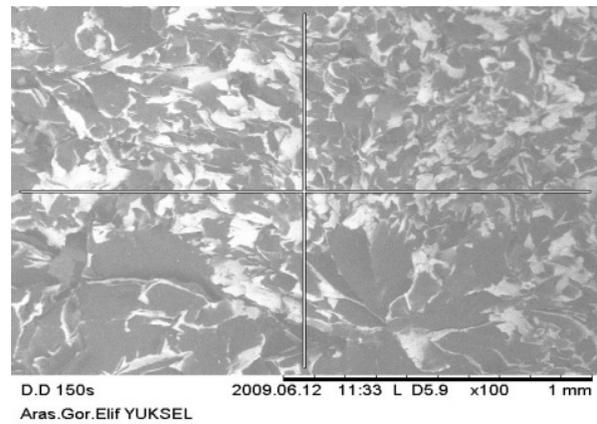
Figure 16. SEM image taken from diffraction section of corroded pump wheel material.

In the image obtained from the inner surface of the pump wheel, it is seen that the inner structure of the cast-iron material has a flower-like image. When the image is observed, it is seen that there is no deformation and corrosion has not advanced up to here and it has no difference with the inner surface of the wheel material whose trial has not been carried out yet (Figure 16).

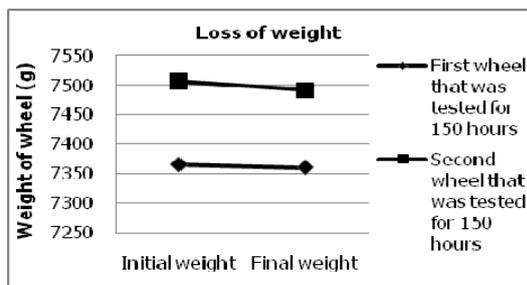
Figure 17. Loss of weight graphics showing the difference between initial and final weights of the first and second wheels that both were tested for 150 hours

It is seen that the weighing loss occurred in the pump wheel whose trial was done in the second 150 hours was more than the first one.
