Discovery Process of the Zeytinburnu Mosaics Outside the City Walls

Citation: Aydemir, O. & Hattap, E. S. (2023). Discovery process of the Zeytinburnu Mosaics outside the city walls. *Journal of Architectural Sciences and Applications*, 8 (2), 926-934.

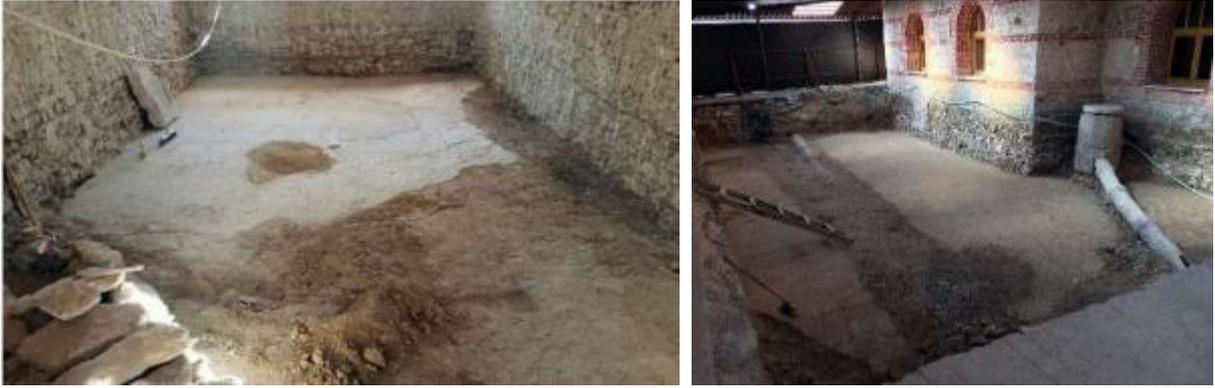
Figure 2. Revealed mosaics from excavations in Zeytinburnu, 2017-2019 (Zeytinburnu Municipalit Archives, 2019)

The excavation process started with the discovery of some partial mosaics during the reinforcement of foundations of the corner room southwest of the Old Municipality Building from the Ottoman Era and was completed under the inspection of the Directorate of Archeological Museums of Istanbul

depending on the permission taken from the Directorate of Conservation Board by Zeytinburnu Municipality (Figure 2).

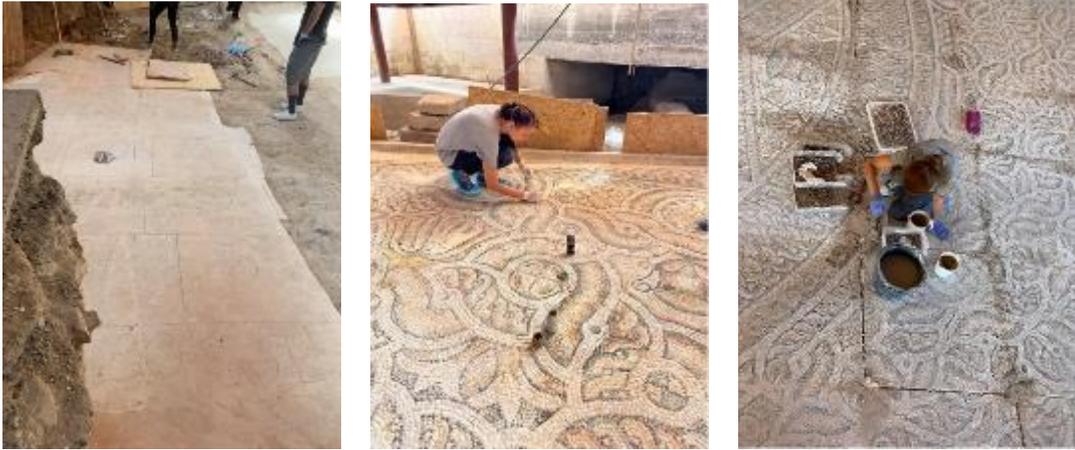
Figure 3. Conservation steps of Zeytinburnu Mosaics (Olcay Aydemir Archives, 2019)

The conservation process of Zeytinburnu mosaics was completed following the steps of removing the soil on top (10-20 m depth of sand and gravel layers) (Çömlekçi & Kahraman, 2022), designing the grid system of the plates, implementing of facing, moving, conservation methods and re-placement of the mosaics to the original locations. All conservation steps were taken according to the critiques

of the conservation report of the Directorate Central and Regional Restoration and Conservation Laboratory of Istanbul (Figure 3, 4, 5).

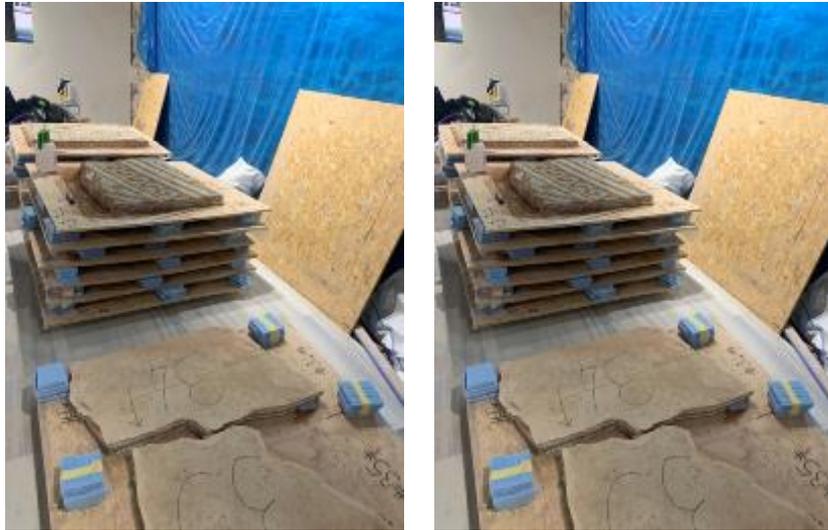
Figure 4. Moving the mosaics after reinforcement and numeration to store them under protection during the conservation implementations (Olcay Aydemir Archives, 2019)

Before the inspection of mortar and movement of the cut plates, a pre-reinforcement way of fixing the parts under risk with the help of cloth was carried out, avoiding any damage to the mosaics.

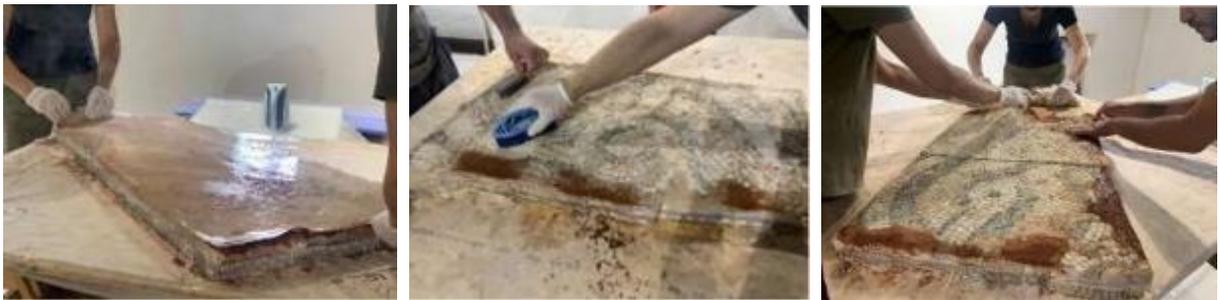
Figure 5. Conservation steps of Zeytinburnu Mosaics (Olcay Aydemir Archives, 2019)

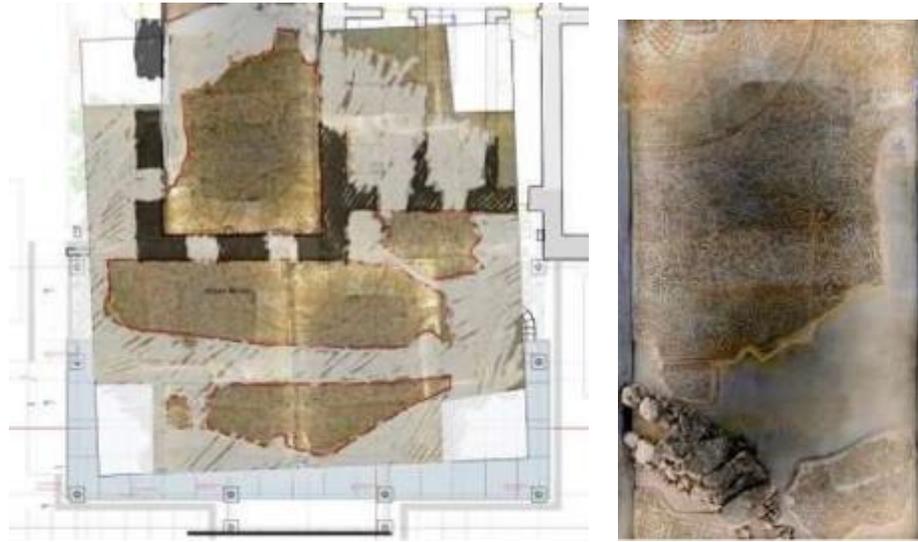
Figure 6. Interiors of Zeytinburnu Mosaics (Zeytinburnu Municipality Archives & Sketches of Celalettin Çelik, 2019)

They were designed in the Opus tessellatum technique and as polychromed. An octagon main pattern is located in the center inside of a circle with borders of waves and braids. The composition is enriched with the surrounding node patterns of the main pattern, triangle and square combinations, and geometric patterns located inside the circles. Floral patterns are formed with green, orange, and purple triangles on a light background inside the circle in the octagon. Among the node patterns outside the main composition; patterns of cantharus, creeper, lotus, and clover are observed. Somolon's Node patterns are also observed (Çömlekçi & Kahraman, 2022).

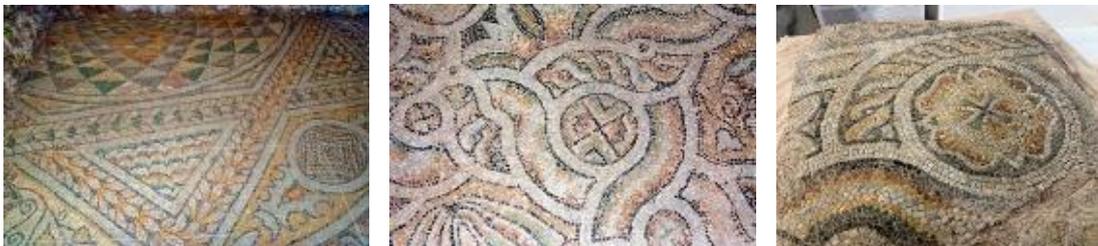
Figure 7. View of vivid colored tessera modules after the cleaning (Zeytinburnu Municipality Archives, 2022)

Zeytinburnu Mosaics are formed of geometric patterns on a mortar layer (of which analysis process is completed) which are an arrangement of triangles colored white, green, yellow, black, brown, orange, and red. Besides the assumption of the 5th-century date in terms of technical observation, it was understood that they belonged to the 5th-6th century during the excavations and depending on the coin of the 5th century found inside the foundation walls (Figure 7). In the following process, the floor mosaic plate was dated to the 4th century AD. The floor mosaics of Istanbul are dated from the 2nd century till the 6th century which are rarely discovered (Yalçın, 2022).

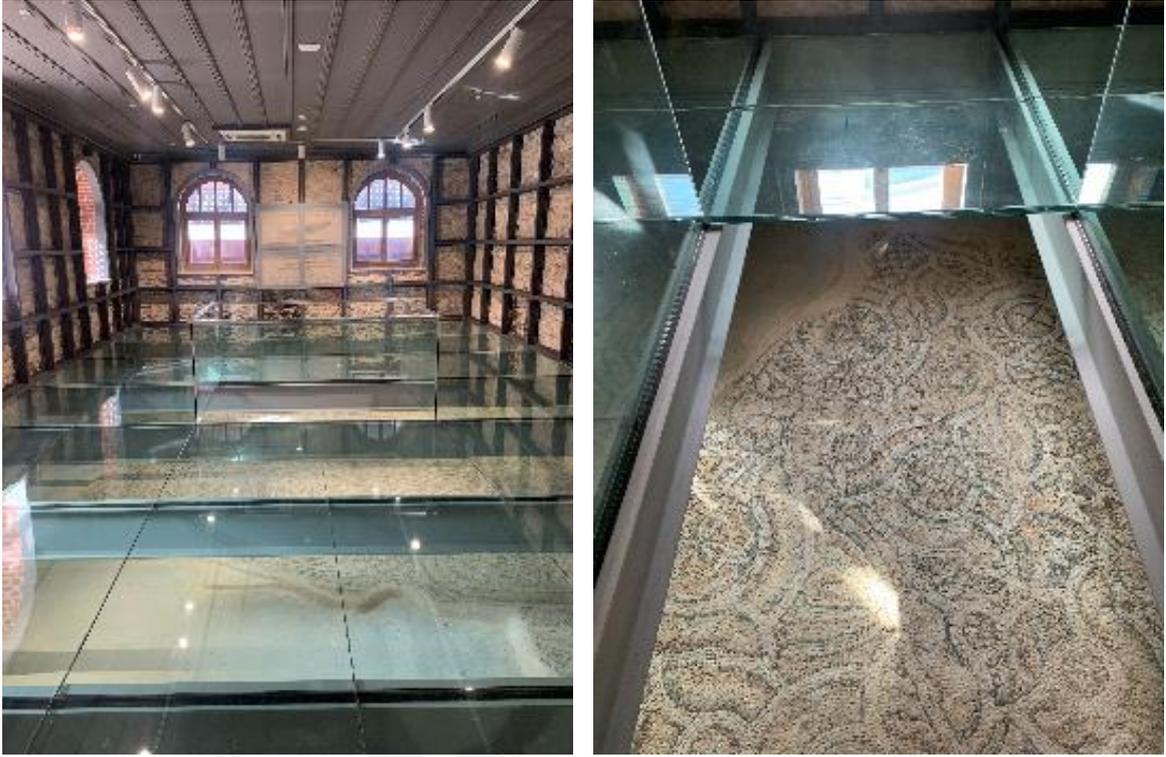
Figure 8. The completed and exhibited part of the mosaics (Sibel Hattap Archives, 2022)

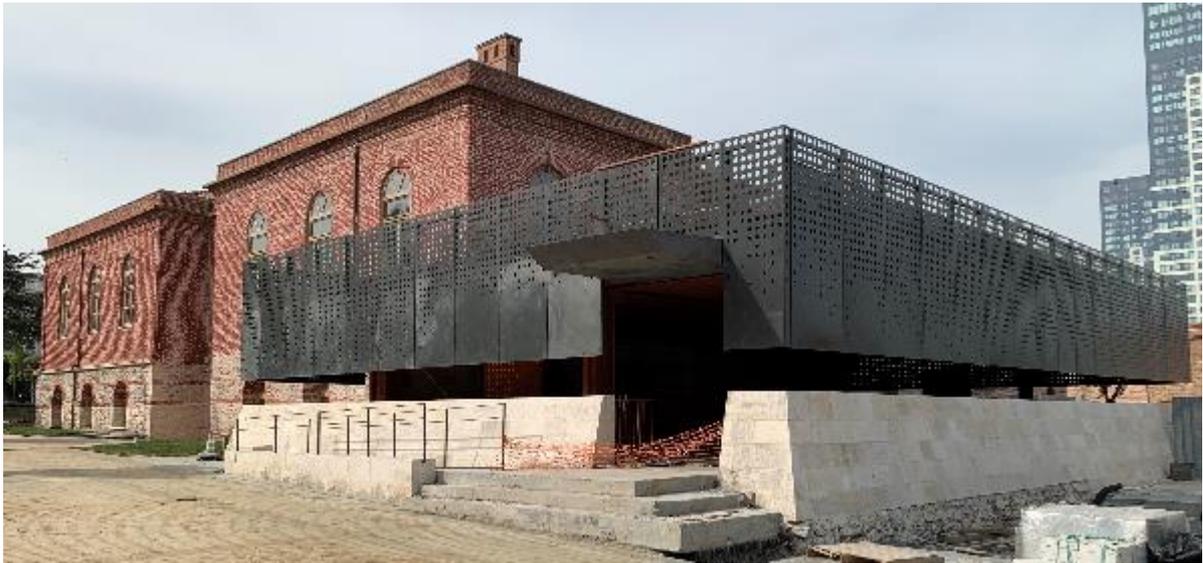
Figure 10. Current view of Kazlıçeşme Art Center (the exterior exhibition part) where the mosaics are exhibited (Sibel Hattap Archives, 2023)

After completion of the excavations, the cleaning and conservation works were carried out and the mosaics were replaced for the exhibition and that part of the building was arranged as a museum (Figure 10, 11).

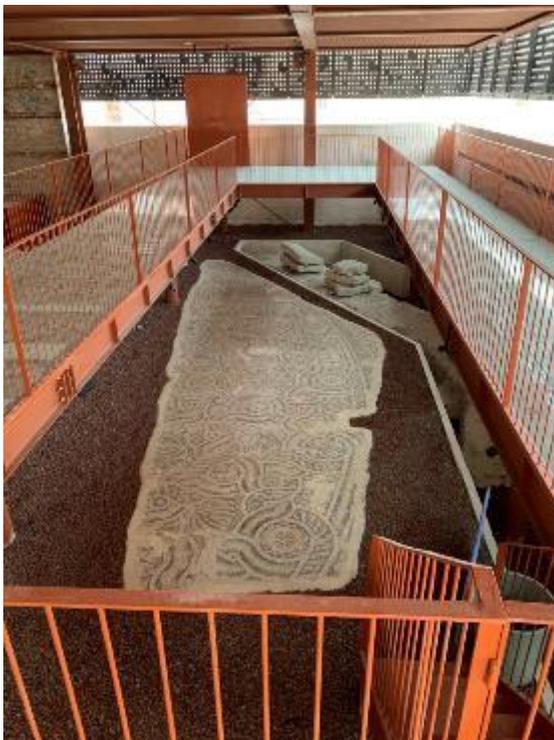
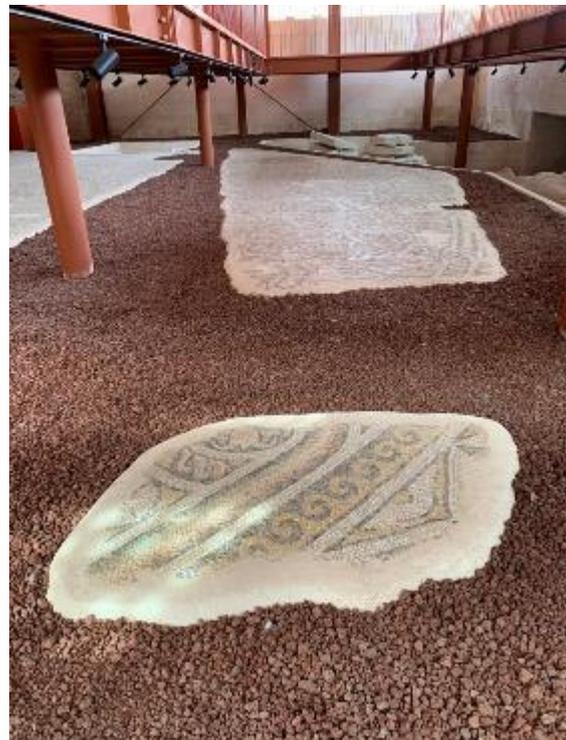
Figure 11. Exhibition of the rest of the mosaics at semi-open part of the building (the exterior exhibition part) (Sibel Hattap Archives, 2023)

The rest part of the mosaics was also revealed and after the conservation steps, they were exhibited in a semi-open area. It is very precious and remarkable that some of the mosaics revealed in Zeytinburnu are exhibited in In-Situ at Kazlıçeşme Art Center which served as a military hospital and then as Zeytinburnu Municipality Building while the rest are exhibited under a semi-open structure outside the building as continuity of the interior ones.

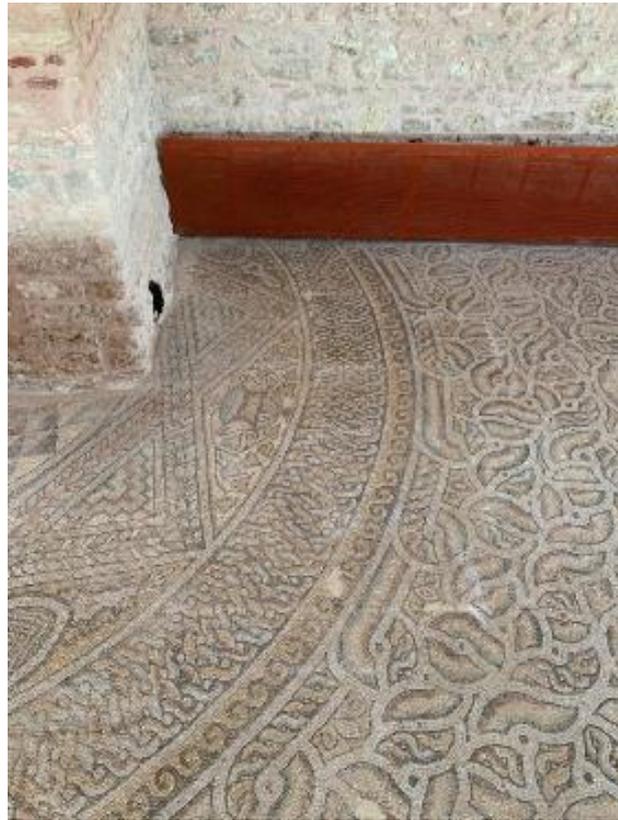
Figure 12. Exhibition of the circular forms of the mosaics at semi-open part of the building (the exterior exhibition part) (Sibel Hattap Archives, 2023)
