Determination of Wear That Can Be Formed at the Cast Iron Wheels of the Centrifuge Pumps Used at Agricultural Irrigation*

Abstract: The extent of this work is operating characteristics of a horizontal shafted centrifugal pump (which has cast iron with lameller graphite wheel) which has been operated for 7 hours on the average. A closed circuit pump system (circulating within itself) which was formed by attaching a horizontal shafted centrifugal pump which can be used in irrigation applications with a drum has been operated for 150 hours at laboratory conditions. To define the operating properties of the pump, its operating characteristics were measured in respect to TS EN ISO 9906/AC. Furthermore, observations have been done to determine whether there is a connection between operating characteristics of the pump and the wear and corrosion occurred on the wheel or not. When spectral analysis, micro-structure and hardness measurements of the wheel materials on which first and second experiments were conducted and unused wrought iron wheel materials were analysed, it has been observed that the wheel materials used in the experiments do not bear the properties required by wrought iron

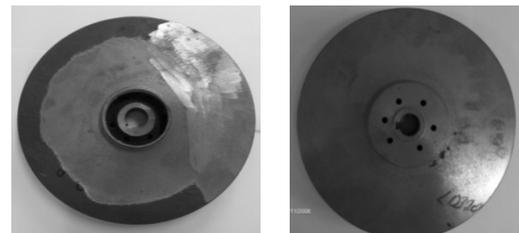
Figure 5. Macro structure images of pump wheel whose trial was done before first 150 hours of experiment.

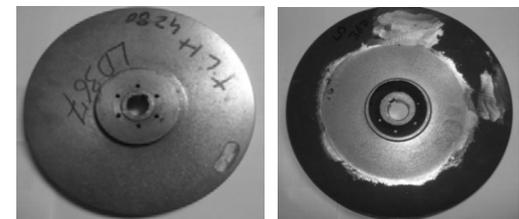
Figure 6. Macro structure images of pump wheel whose trial was done before second 150 hours of experiment.

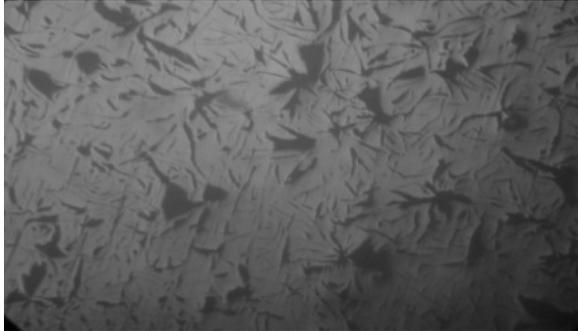
Figure 7. Micro structure image of cast-iron wheel structure whose trial was not carried out.

Graphite type of materials whose micro structure images were given is A+C, perlite rate is 80-85 % and graphite size is 2-4.

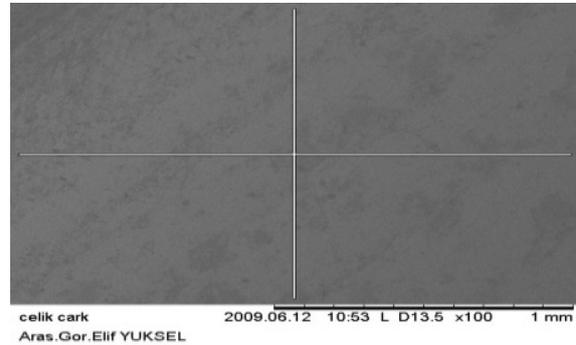
(a)

In Figure 8a, images of outer surface of pump wheel is given. When the image is observed it is seen that there is no crack or scratch on the surface. In Figure 8b an image from the inner surface of cast-iron material cracked for observation is seen.
